INTERIM REPORT
TO CONGRESS

THE STREAMBANK EROSION CONTROL
EVALUATION AND DEMONSTRATION ACT OF 1974

September 1978

U. S. ARMY
CORPS OF ENGINEERS

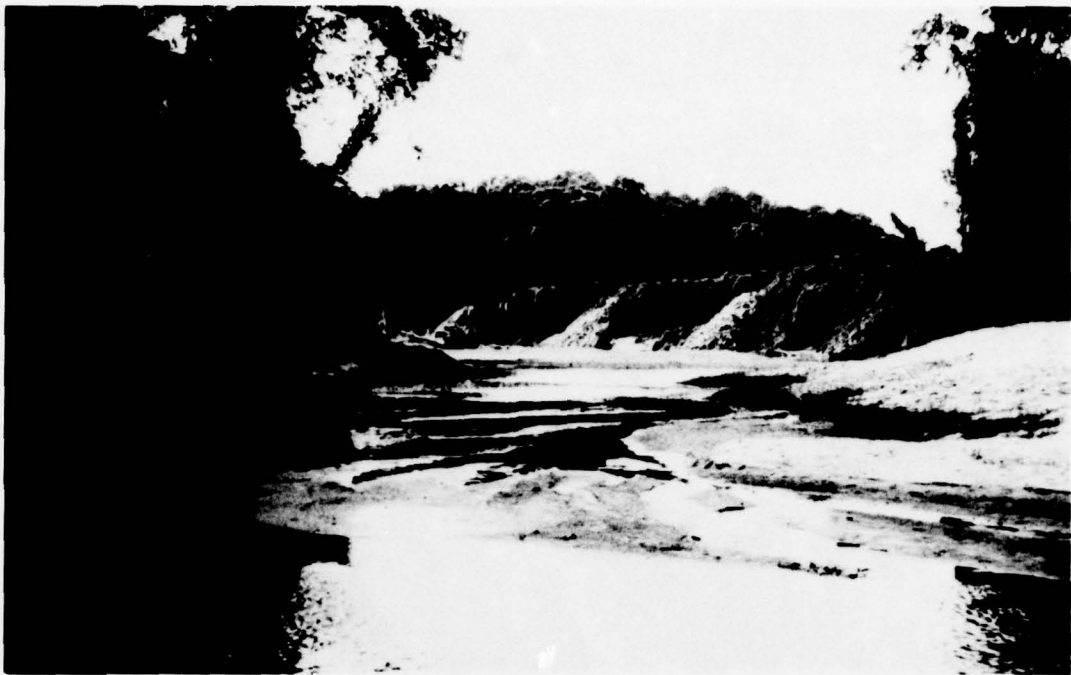
Photo 15. Riprap hard points with kudzu

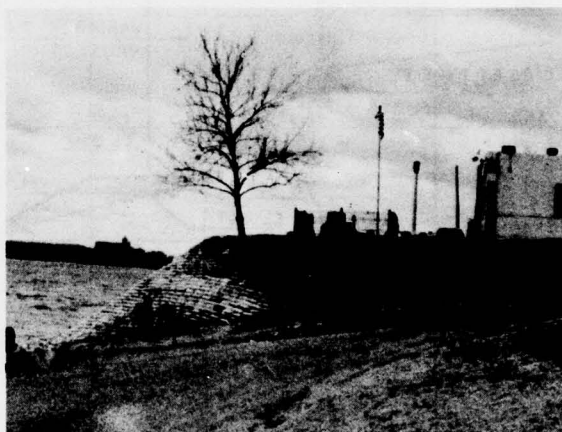
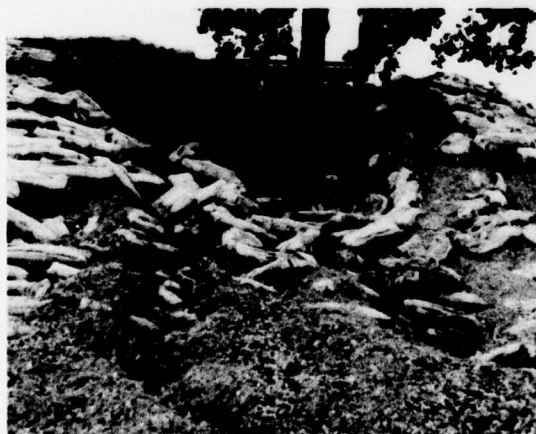
DEMONSTRATION SITE
MOUNT VERNON, INDIANA

WATER WORKS BANK PROTECTED
BY NYLON-REINFORCED SAND-
CEMENT FILLED PAPER BAGS AS
VIEWED FROM UPSTREAM.
JANUARY 1977

WATER WORKS BANK DAMAGED BY
SPRING FLOODS AND HEAVY RAIN.
THIS AREA WAS REPAIRED WITH
RIPRAP AND A CATCH BASIN AND
STORM DRAIN. OCTOBER 1977

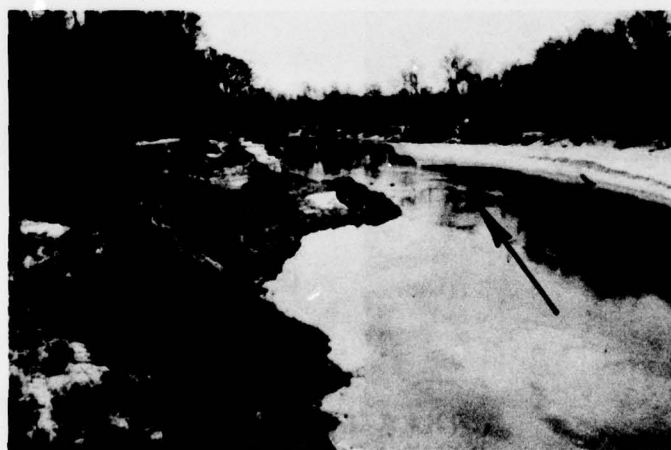
PHOTO 3
AFTER FLOOD OF
21 NOVEMBER 1977
(7 DECEMBER 1977)

BATUPAN BOGUE, ITEM 4A
TIRE REVETMENT (FAILURE)
